DAILY REPORT

PROJECT NAME: Old Harbor Small Boat Harbor Installation

CONTRACTOR: West Construction

WEATHER (AM): Broken overcast, cold, slight breeze **DATE:** January 22, 2010

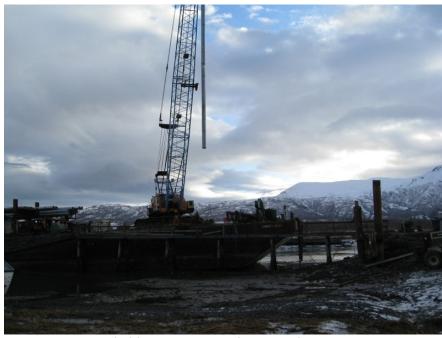
Image 1: Grounded barge setting pile vertical

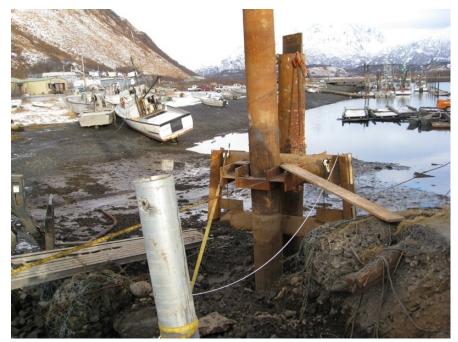
Image 3: Template driven for bent #3

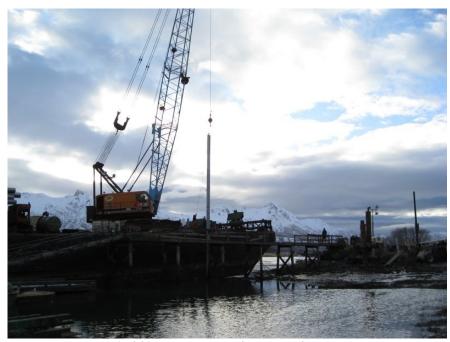
Image 2: Grounded barge setting pile vertical

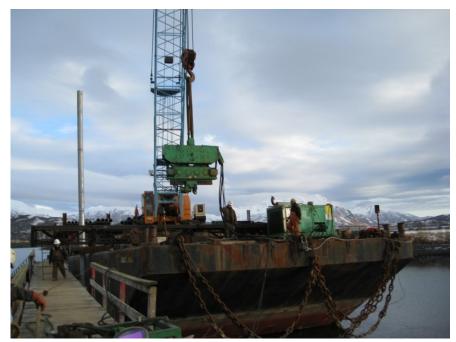
Image 4: Getting vibratory hammer ready

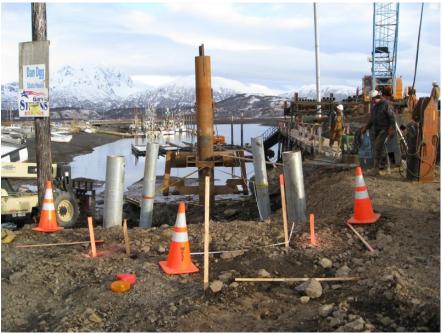
Image 5: looking down the centerline of the trestle

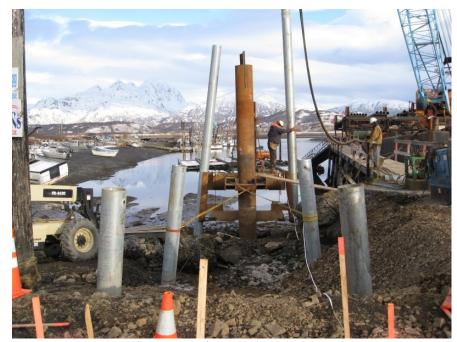
01:00 PM • Impact picked, driving starts on pile 6S @ 1:05pm, ends 1:10pm

Image 7: Setting pile 6S into the template

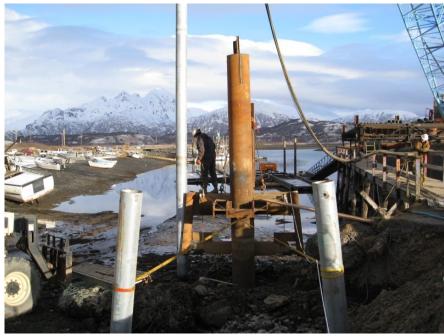
01:15 PM • Pile 5N driven, ends 1:20pm, Last four feet driven at 42 blows per minute

Image 6: Setting pile 5N

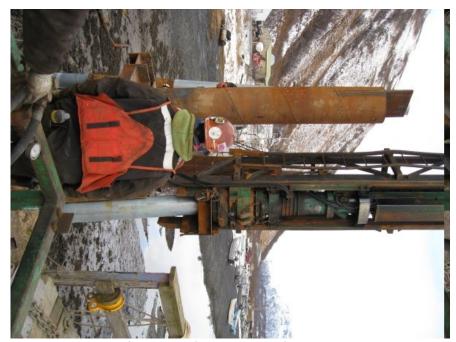
Image 8: Setting the impact hammer on pile 6S

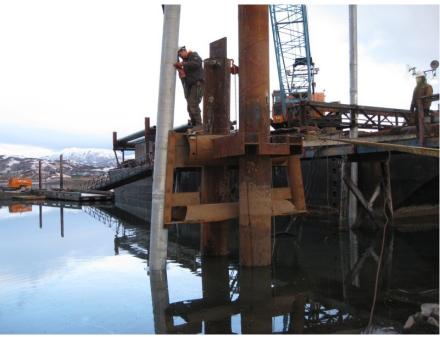
• Pile 7N vibed into place. Pilebucks have some difficulty driving, has to be repositioned several times, then driven ~20' and left due to obstruction which

prevented driving with vibe hammer.

Image 9: Setting pile 7N in template with the vibratory hammer

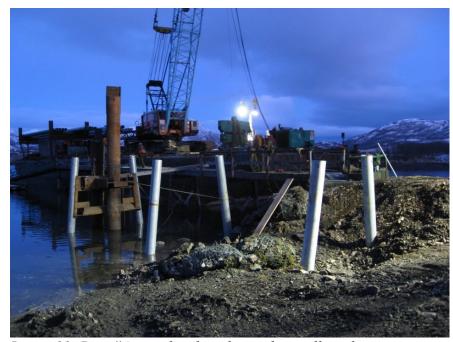
Image 11: Bent #4 completed, with template still in place

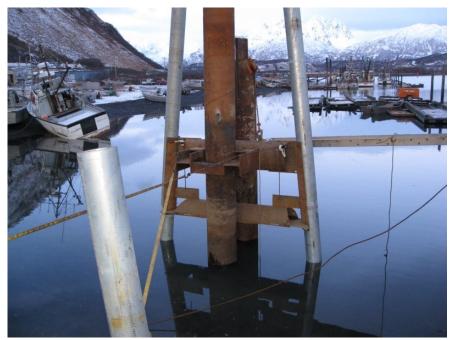
Image 10: Bent #4 with piles in place ready for impact hammer

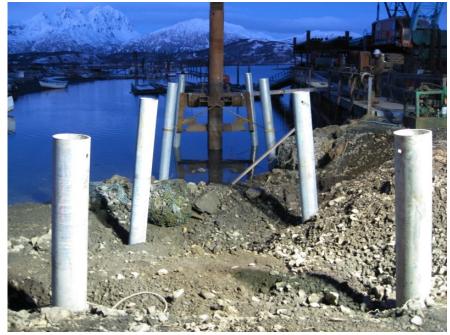
Image 12: Looking down centerline of trestle
